Report into the stockproofing options of Tregonetha Downs

Produced by: Jason Appleby, Reserves Officer, Cornwall Wildlife Trust

Date: April 2010

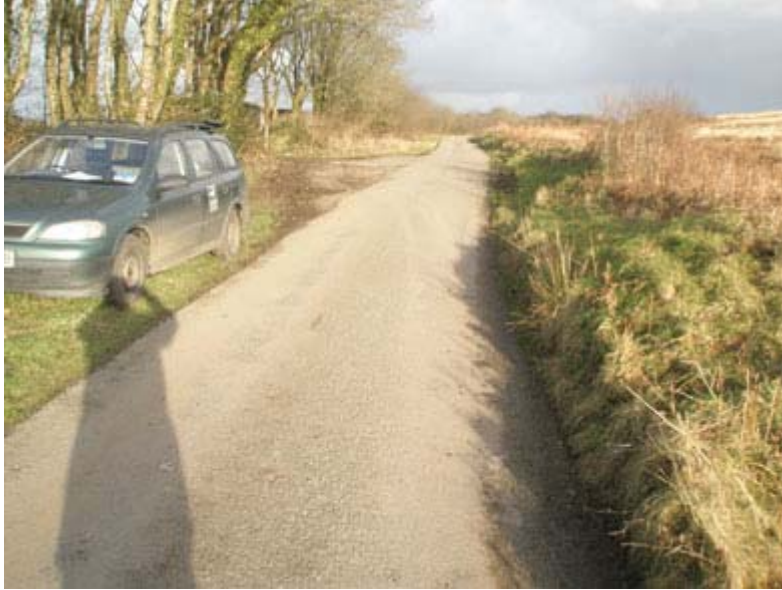
At the eastern limit of the Kernick road there is a well used farm gate with a large lay-by. The road at this point is straight and so suitable for a grid (Photo 1) but the grid would have to be positioned several meters to the west so as not to impede access to the gate and lay-by. There is ample space for pedestrian/equestrian by-pass facilities at this point.

Photo 1. Proposed location of northern cattle grid on the Kernick Road.

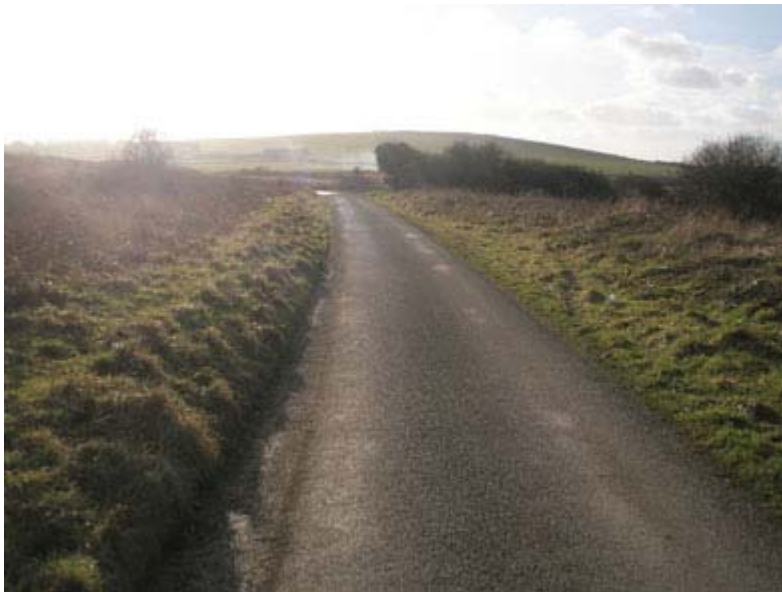
A second cattle grid near to the junction of the Kernick Road and the B3374 would reduce the need for fencing on the Kernick road (Photo 2). Although the Kernick Road is straight at this point a cattle grid would need to be positioned several meters back from the junction so as not to present a hazard to vehicles turning off the B3374 (Photo 3). The exact position of a western cattle grid would need to be decided following thorough consultation with the relevant Highways Area Manager.

Photo 2. Proposed location of southern cattle grid on the Kernick Road

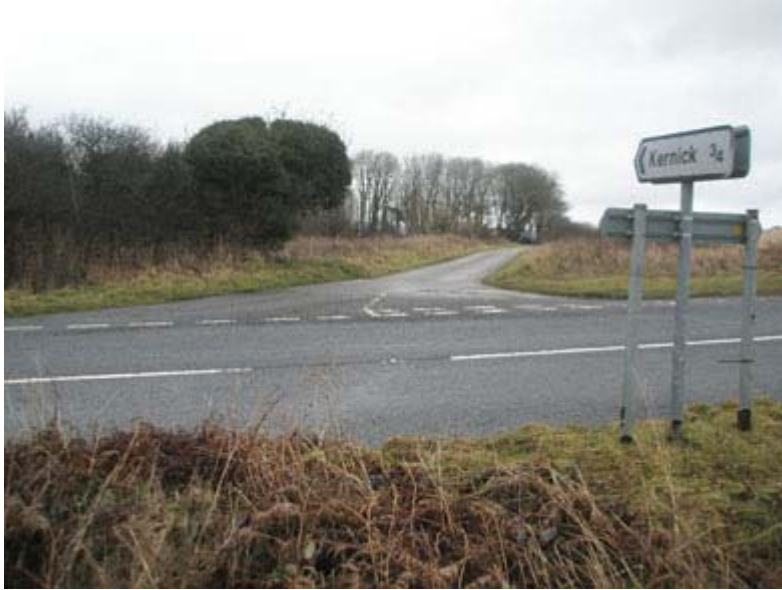
Photo 3. Junction of the Kernick Road and B3374

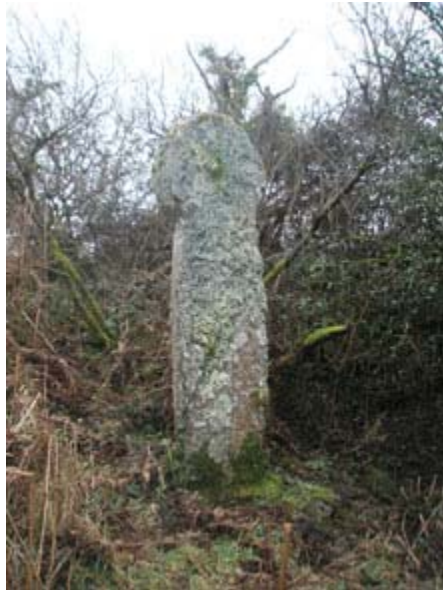
Compartment I is the largest area of Tregonetha Downs. There is a stone cross within this section which may require additional fencing to prevent stock damage (Photo 4).

Photo 4. Stone cross within Compartment I

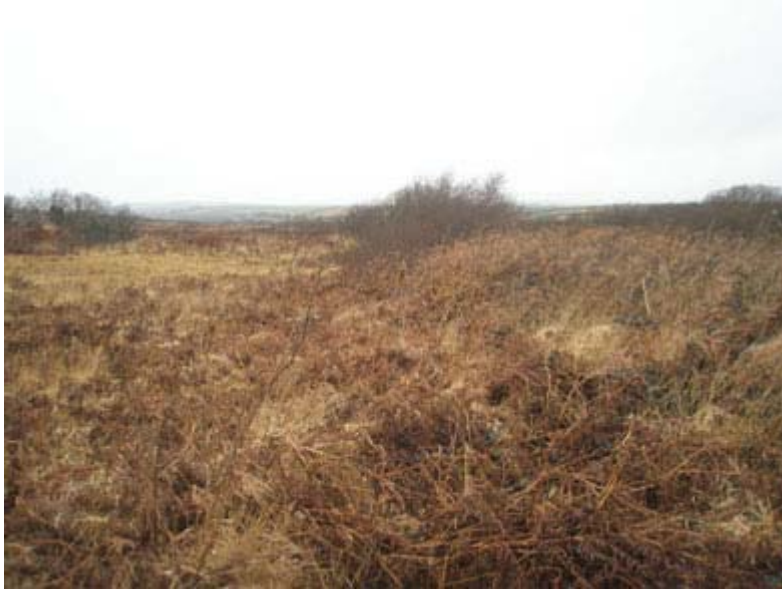
The eastern boundary of Compartment I is formed by the B3374. For much of its length there is a bank approximately 1 meter high running alongside the road (Photos 5, 6, 7, 8 and 9) which would obscure a fenceline to some degree but it is likely that it would still be visible in places especially to the south east, less so to the north as the bank is fairly scrubby in this area.

Photo 5. Eastern boundary of compartment I facing north west

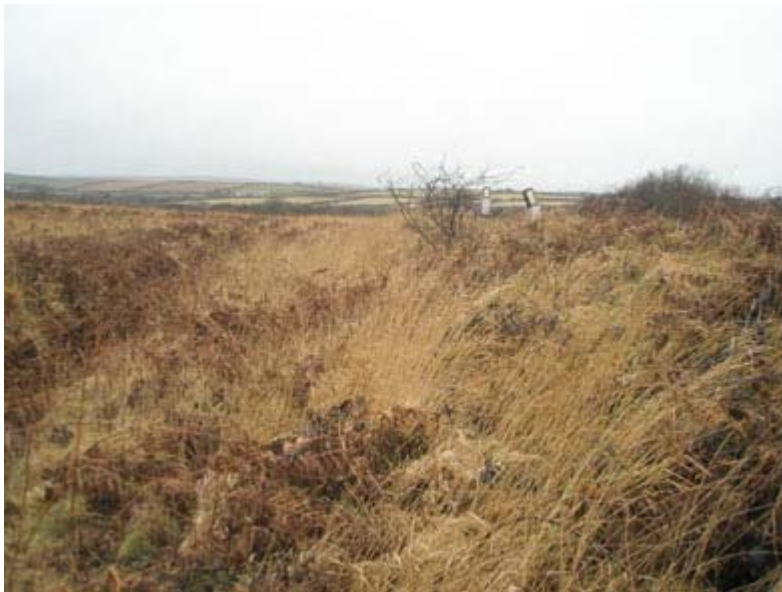
Photo 6. Bank along roadside forming eastern boundary of Compartment I

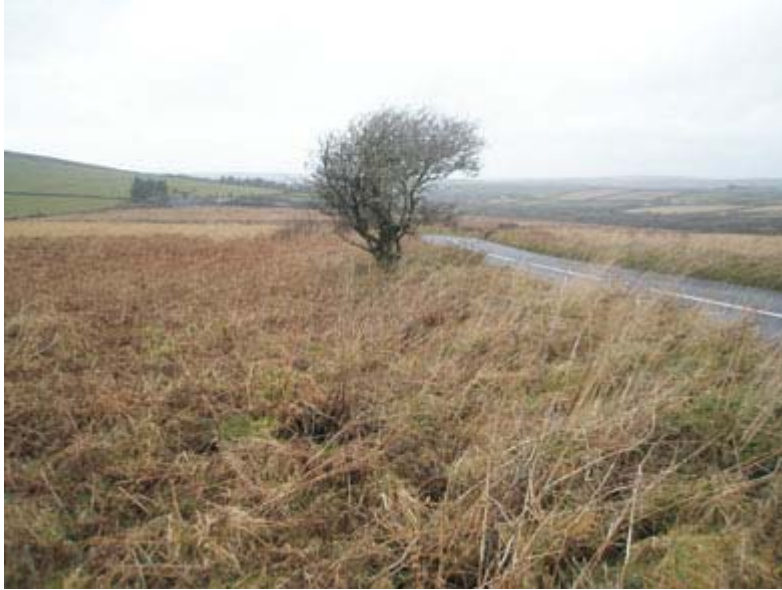
Photo 7. Eastern boundary of Compartment I facing north

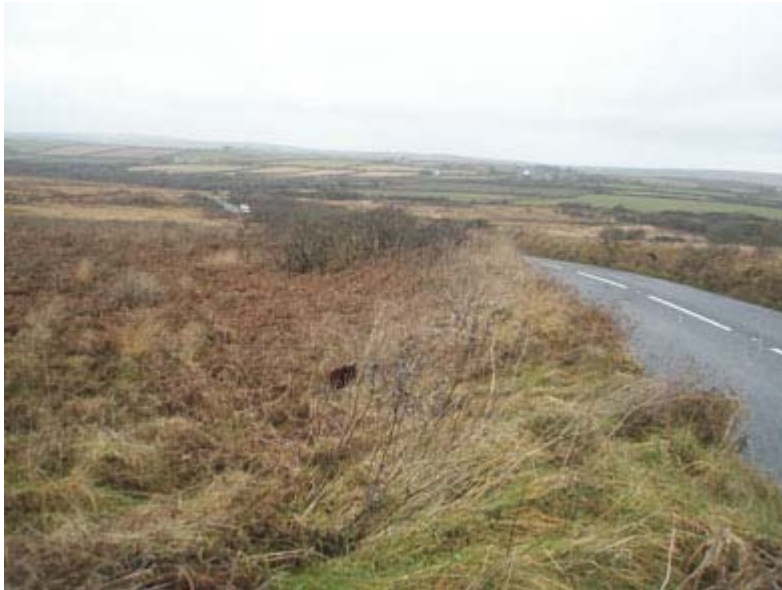
Photo 8. Eastern boundary of Compartment I from the south eastern corner

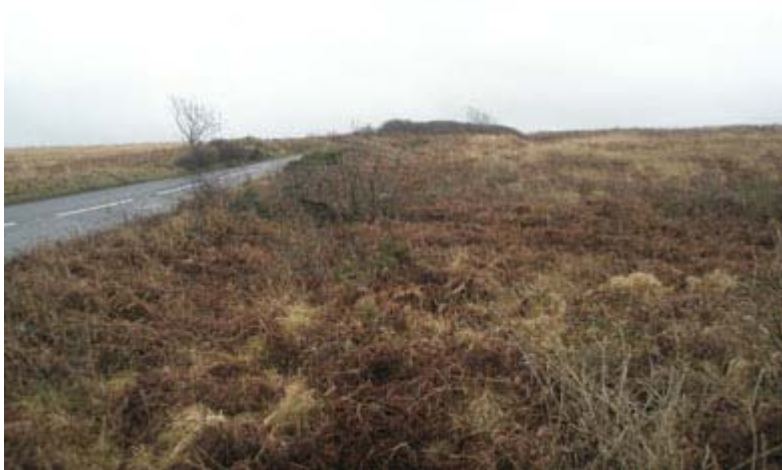
Photo 9. Eastern boundary of Compartment I facing south east

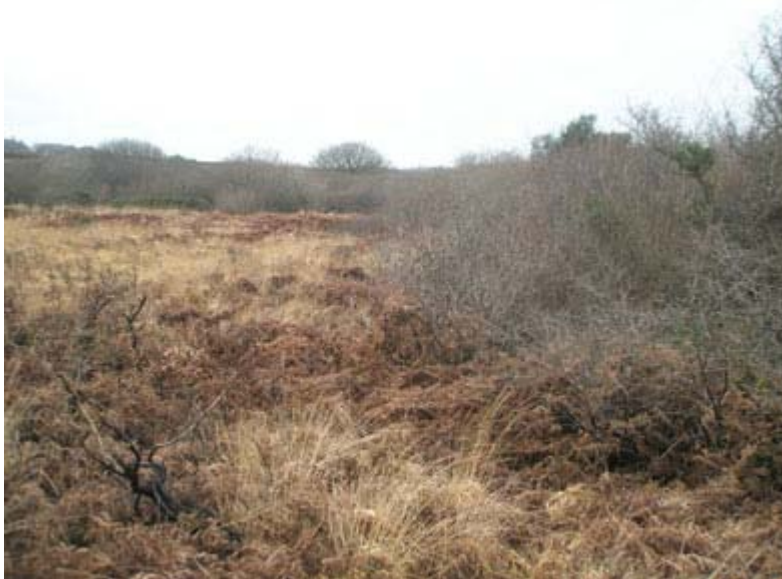
The northern boundary of Compartment I is formed by a small stream (Photo 10). This stream is lined with scrub which would allow a new fence to be hidden. Approximately half way along the northern boundary, to the north of the stream, there is infrastructure in place to take water from the stream to water stock (Photo 11). It is unclear whether this is still operational but Cornwall Wildlife Trust may be able to utilize this to service stock in this compartment. Failing this a similar system could be set up on the Trust owned bank of the river.

Photo 10. Scrub forming northern boundary of Compartment I

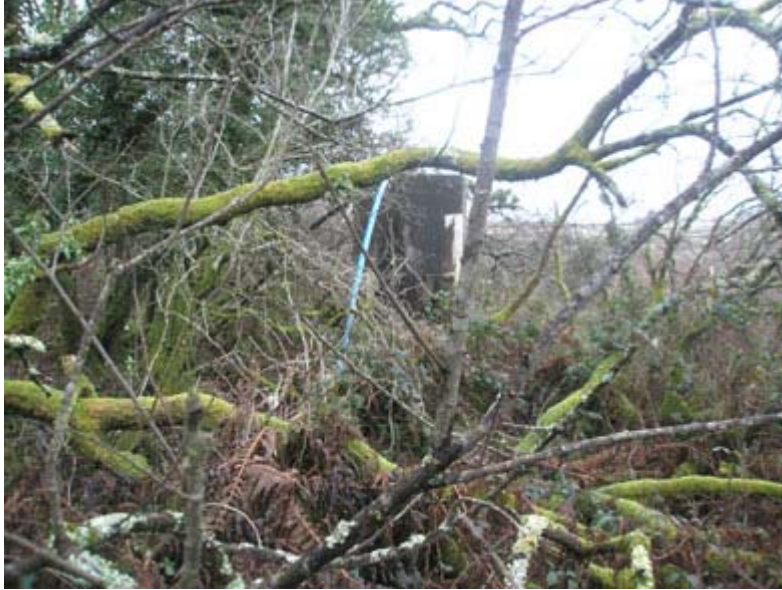
Photo 11. Location of a possible watering point within scrub of the northern boundary of Compartment 1

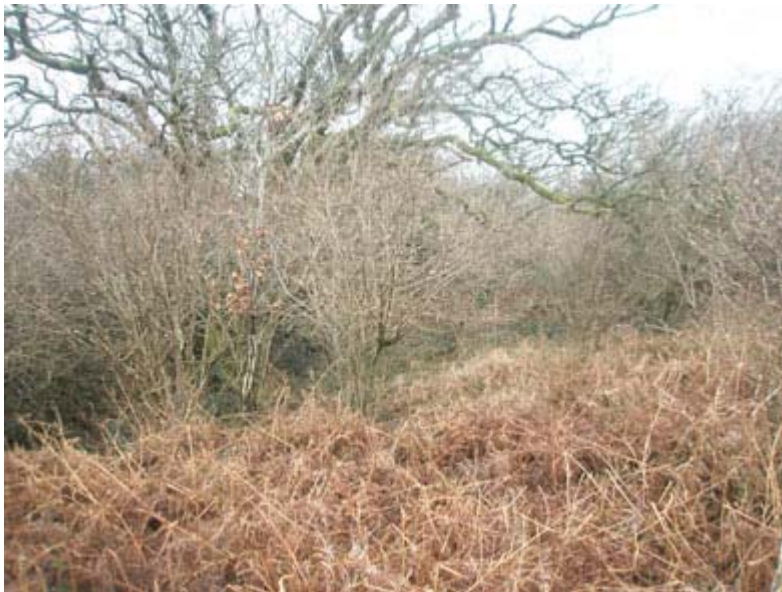
Due to the large amount of scrub in the northern section of this compartment (Photo 12) a fence line would need to be positioned approximately 10-15 meters away from the existing boundary until it reaches the track leading to Castle Farm. There is currently a farm gate on this track which would provide the Trust with a useful point of entry to the western areas of the site (Photos 13 and 14) and the potential to install stock handling facilities. A second gate would be required where the track enters Trust land. The farm track continues into the common for several meters and eventually becomes a public footpath as shown on the maps; the presence of the public footpath would necessitate either a stile or kissing gate to be installed at this point. From this point on the boundary runs east-west to form the southern boundary.

Photo 12. Mature scrub forming northern section of the western boundary of Compartment 1

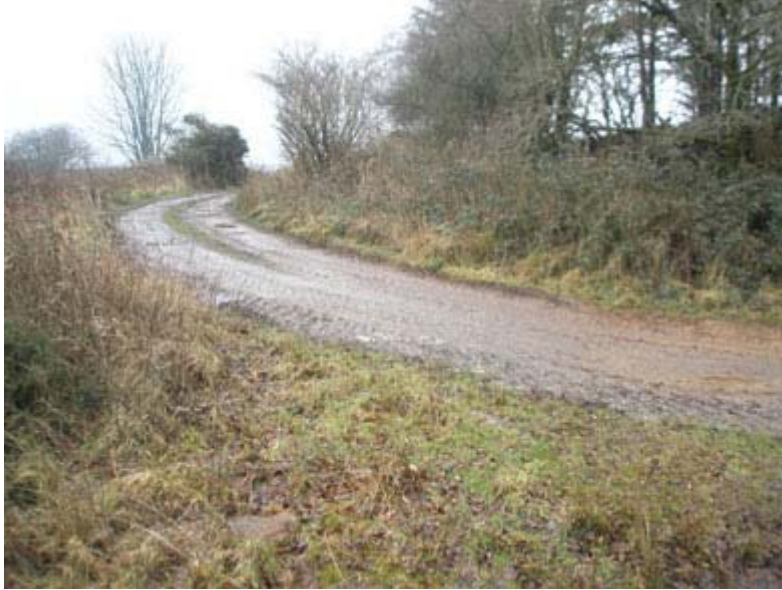
Photo 13. Track to Castle Farm within western boundary of Compartment I

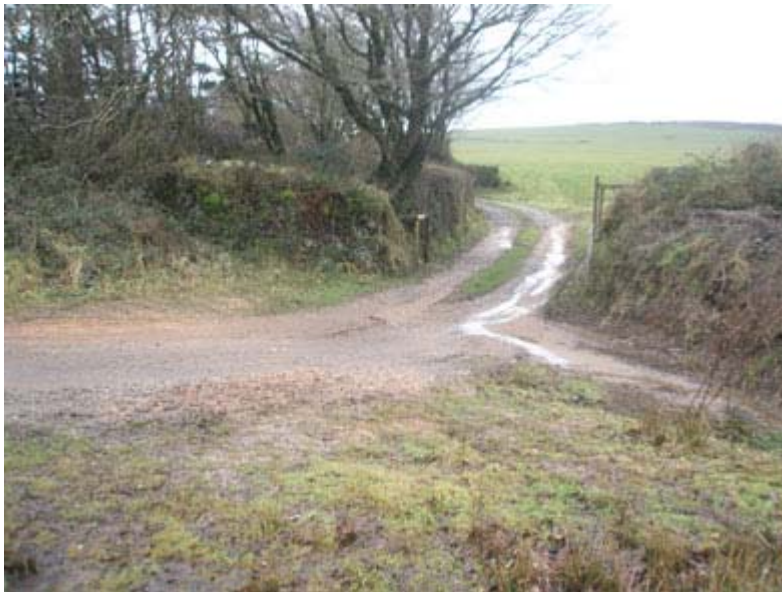
Photo 14. Track to Castle Farm within western boundary of Compartment I providing a potential access point to this section of the downs

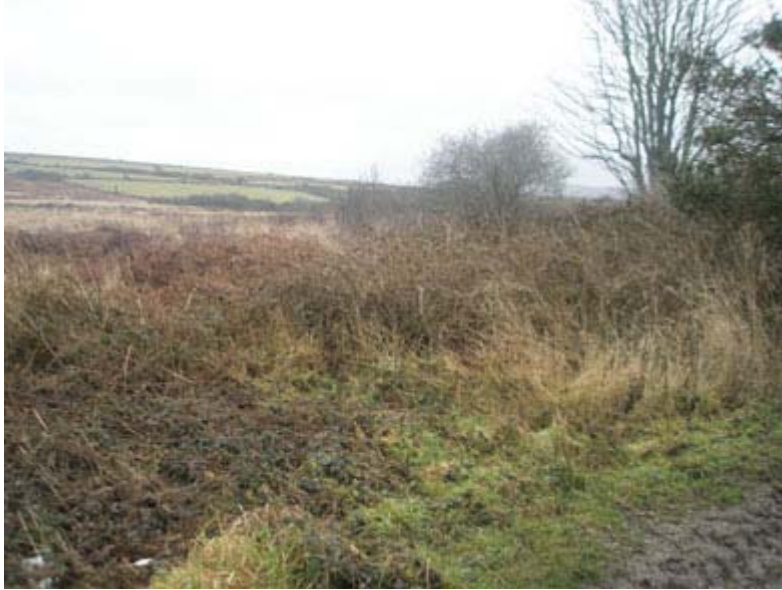
The southern boundary comprises of a Cornish hedge approximately 1 meter high which runs all the way to the eastern corner to meet the B3374. Although this would not hide a new fenceline it would mask its silhouette (Photos 15, 16, 17 and 18). At the far eastern corner of the site there is an interpretation board and a flat area where visitors are able to park. In order to maintain visitor access to the common a new fenceline should allow parking to continue and include a kissing gate or stile and a farm gate to allow the Trust vehicular access to the eastern areas of the site. If a farm gate were to be placed at this location it should be a wooden gate which would be more aesthetically pleasing than a galvanised gate.

Photo 15. Southern boundary of Compartment I leading south from Castle Farm

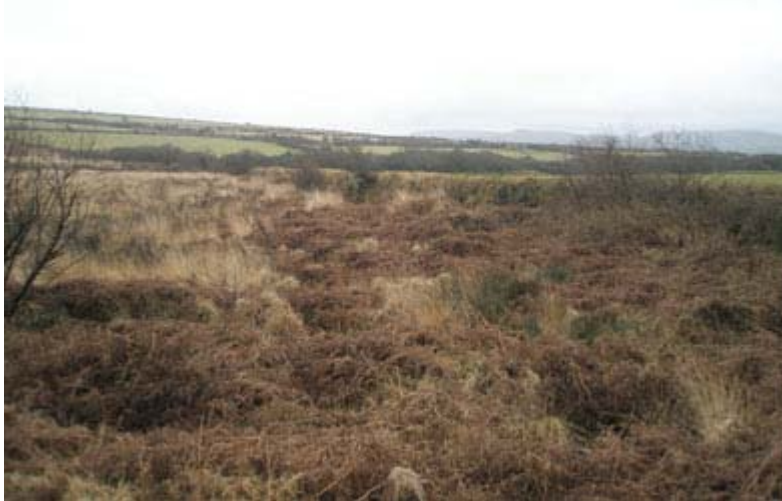
Photo 16. Southern boundary of Compartment I facing east, showing existing Cornish hedge

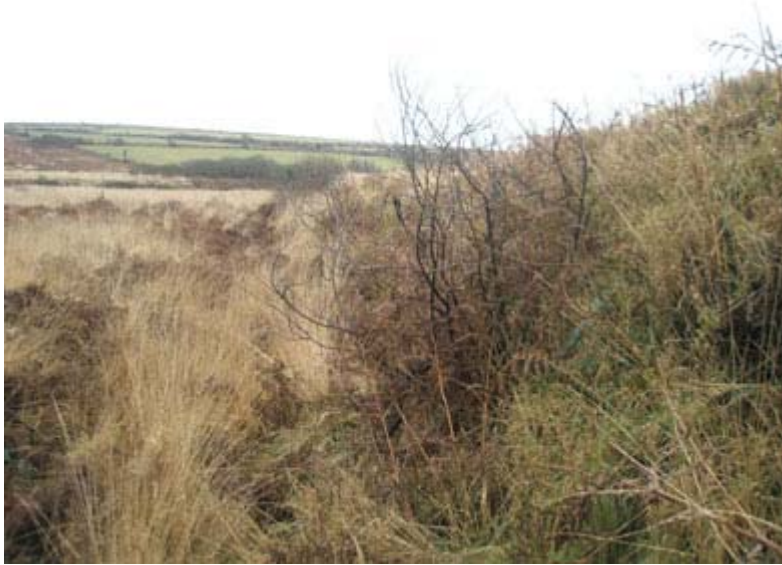
Photo 17. Detail of Cornish hedge forming southern boundary of Compartment I

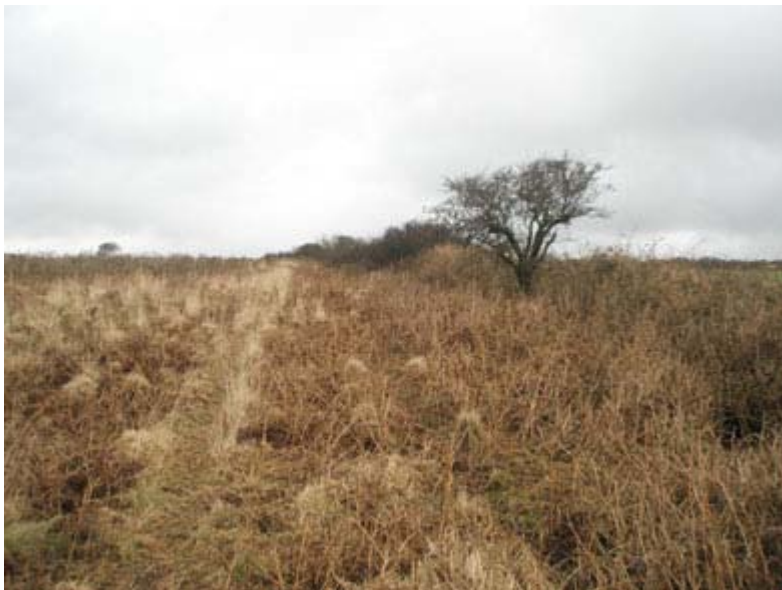
Photo 18. Southern boundary of Compartment I facing east, showing existing Cornish hedge

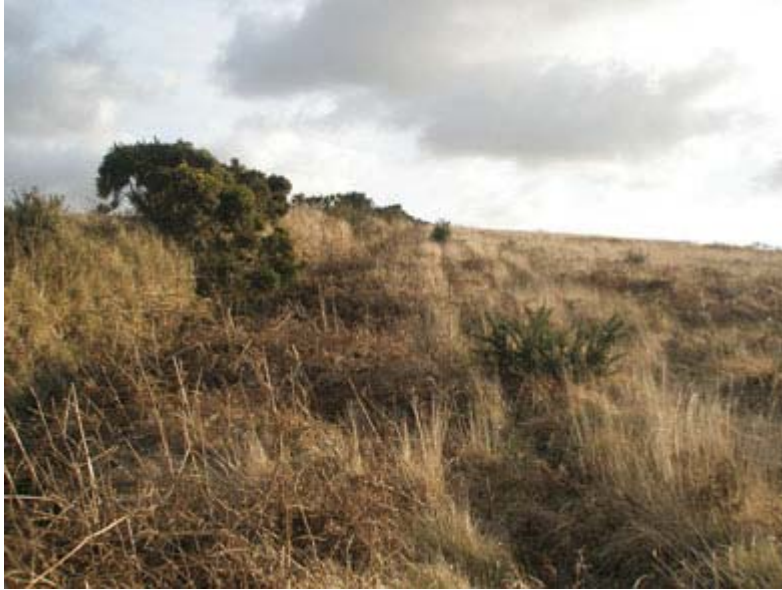
The eastern boundary of Compartment 2 is currently formed by a Cornish hedge approximately 1 meter high (Photo 19). Although this hedge would not hide the hedge it would mask its silhouette. To the south there is an area of scrub which offers the opportunity to hide the fenceline.

Photo 19. Eastern boundary of Compartment 2 facing south, showing existing Cornish hedge

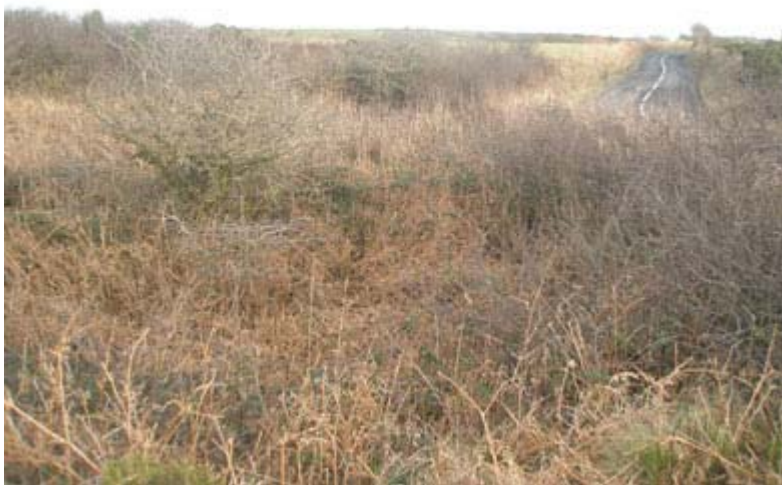
The southern and western boundaries of Compartment 2 are formed by the B3374. As with its borders with Compartment 1, the road has a bank running along side it for most of its length which would hide a fenceline to some degree although it would still be visible in places (Photos 20, 21 and 22). If a car parking area is to be maintained in Compartment 1 as suggested above, a stile or kissing gate would be fitted in the southern boundary of Compartment 2 to allow access across the road. A fence line along this boundary would need to tie in with the fencing and gate associated with the western cattle grid.

Photo 20. South eastern corner of Compartment 2 showing B3374

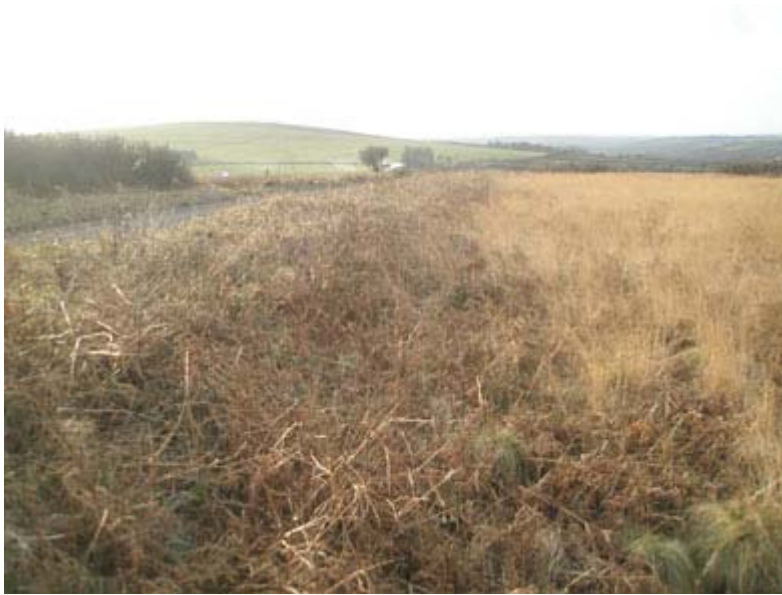
Photo 21. Southern boundary of Compartment 2 formed by a bank running along the B3374

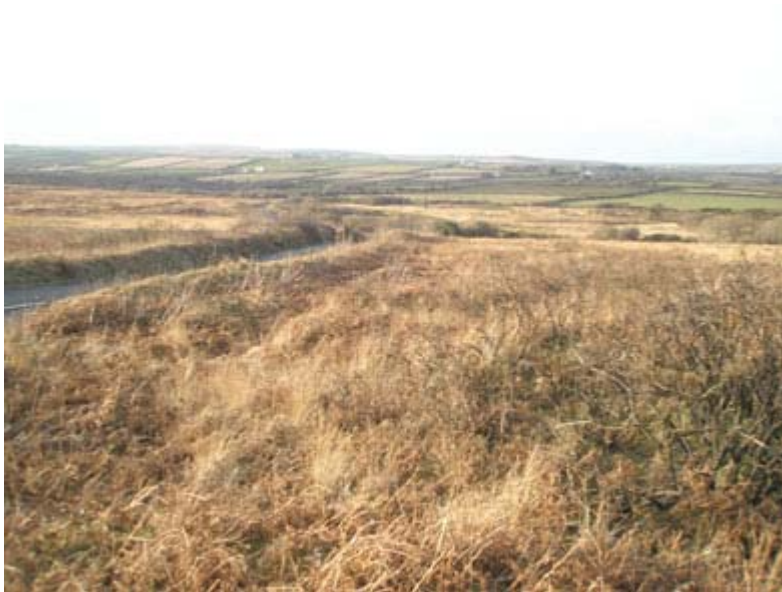
Photo 22. Western boundary of Compartment 2 showing raised bank.

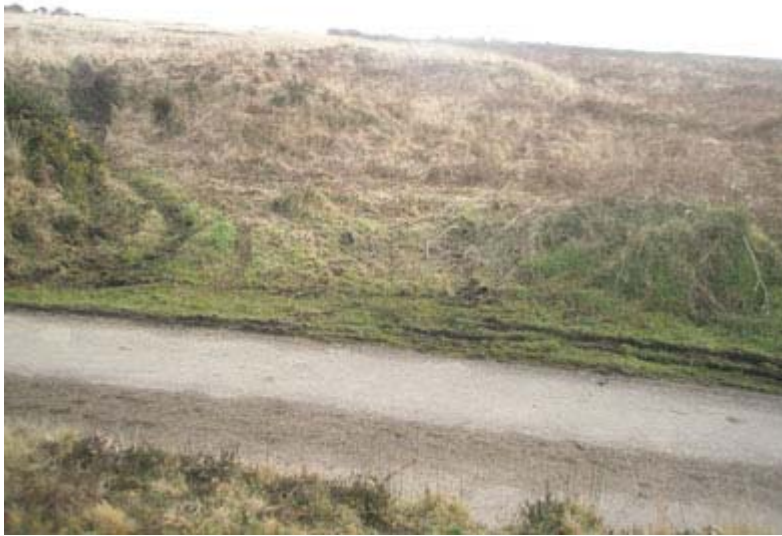
The northern boundary of Compartment 2 is formed by the Kernick road. Two cattle grids placed on the Kernick road will negate the need for fencing the western section of this boundary. The eastern section of the boundary will require fencing, there is currently a Cornish hedge running the full length of this boundary which will hide the fenceline from the road. Close to the western limit of this boundary there is a gap in this hedge which offers a good opportunity to place a farm gate to allow the Trust vehicular access to this compartment (Photo 23). A farm gate should have an associated kissing gate or stile fitted to allow pedestrian access.

Photo 23. Northern boundary of Compartment 2 showing gap in hedge suitable for a gate

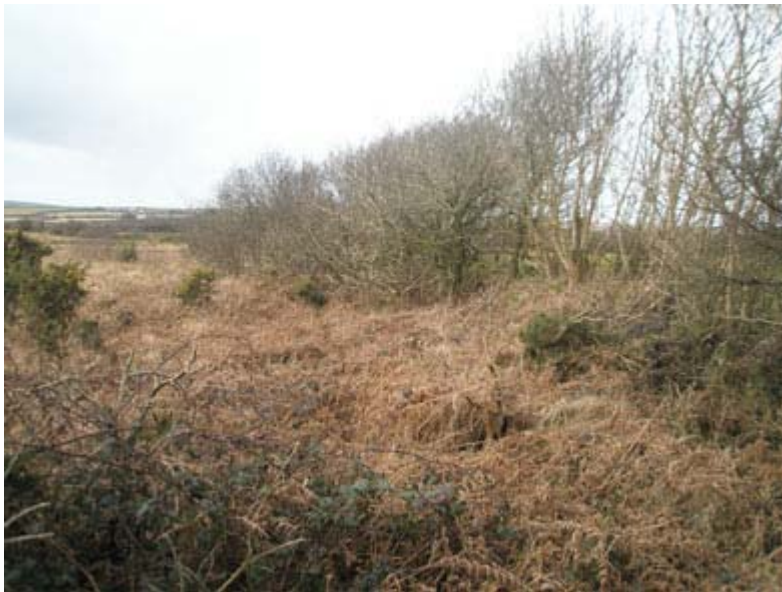
The eastern boundary of this compartment is comprised of a Cornish hedge which to the south is topped with mature vegetation (Photo 24). A fenceline running close to this feature would be well hidden for most of the southern section of this boundary. There is a gap in this hedge with a tack leading to the north eastern section of the SSSI (Photo 25). There is currently a pool of water within this gap which appears permanent. This section of the SSSI is not in our ownership but is part of the common therefore it would be appropriate to install a farm gate and style into in this gap.

Photo 24. Eastern boundary of Compartment 3 showing overgrown Cornish hedge

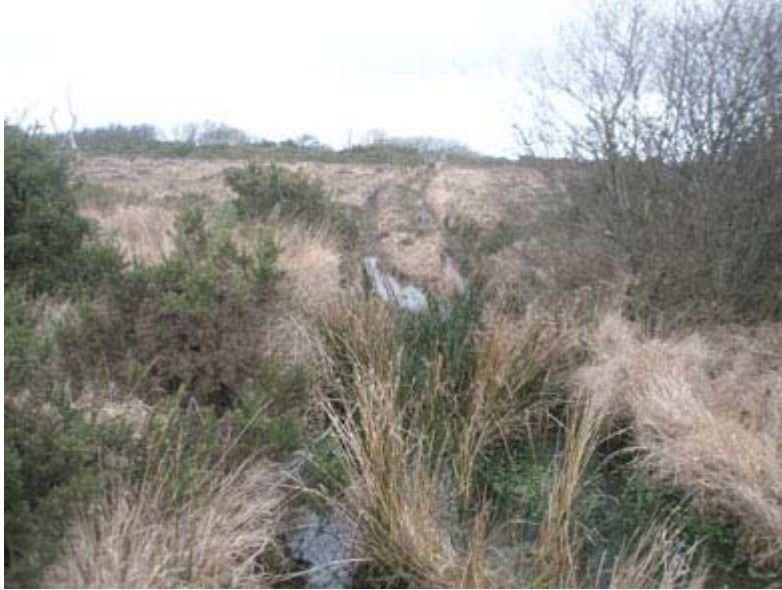
Photo 25. Gap in hedge forming eastern boundary of
Compartment 3 leading into north eastern section of the SSSI

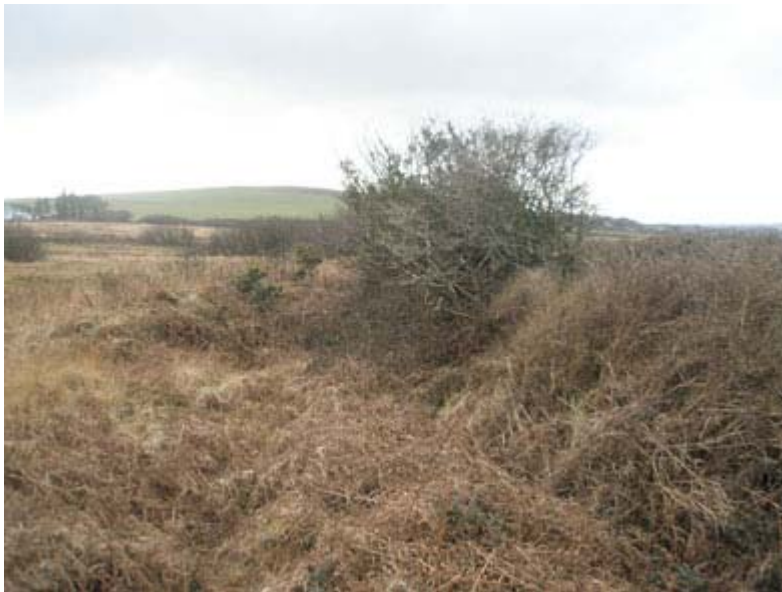
The northern boundary is similar in character to the eastern boundary. Although the hedge is less well defined (Photo 26) it does offer the opportunity to hide the fenceline. The north western corner of this compartment is completely scrubbed over with gorse and blackthorn and would allow the fence to be well hidden.

Photo 26. Northern boundary of Compartment 3 showing
existing Cornish hedge

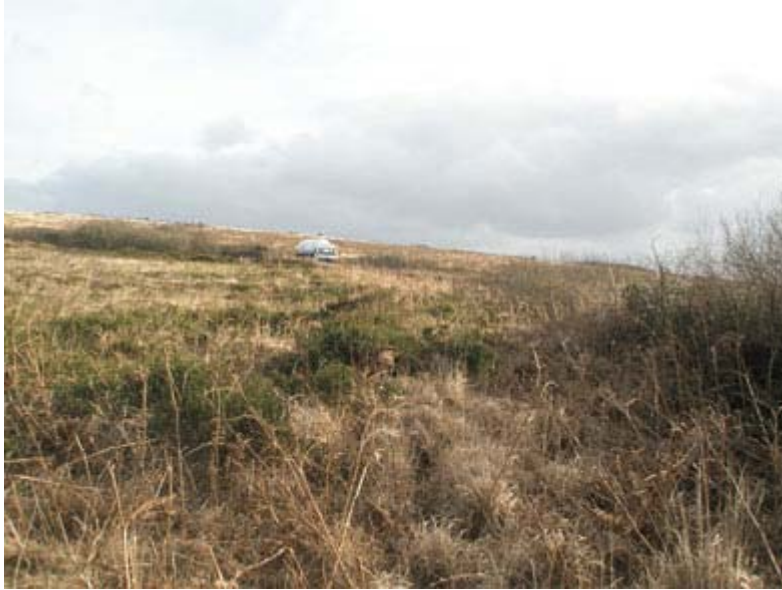
The western boundary is formed by the B3374. There is less of a bank along this boundary than at other roadside boundaries and so a fenceline would be quite obvious

in places (Photo 27) although there is some scrub in places which would hide the fence to some extent.

Photo 27. Southern boundary of Compartment 3 showing B3374 in background

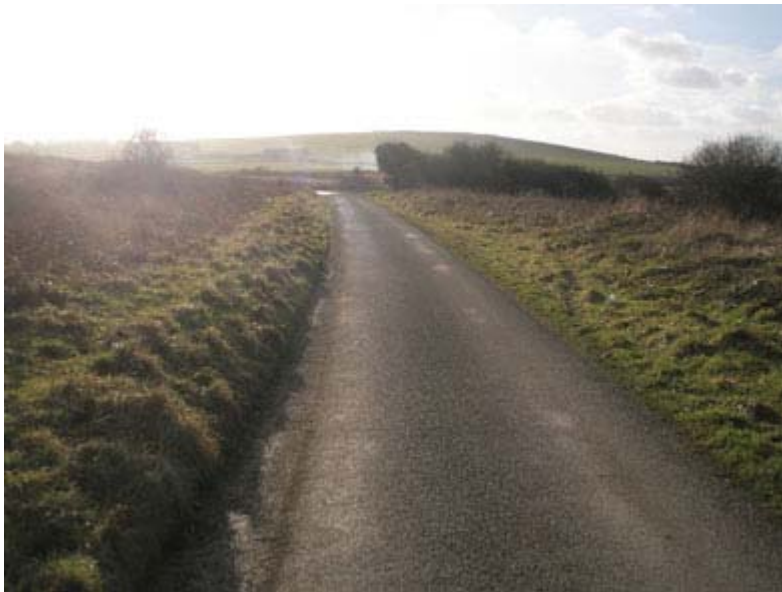
Photo 28. Kernick Road forming the southern boundary of Compartment 3 (right) and Northern boundary of Compartment 2 (left). The installation of cattle grids on this road would negate the need to fence these boundaries.
